Manhole Inspection Summary

Manhole # S09KK1019MH

Insp Date: **5/17/07 9:59 AM**

Location Address: **3503 WOODLAND AVE**

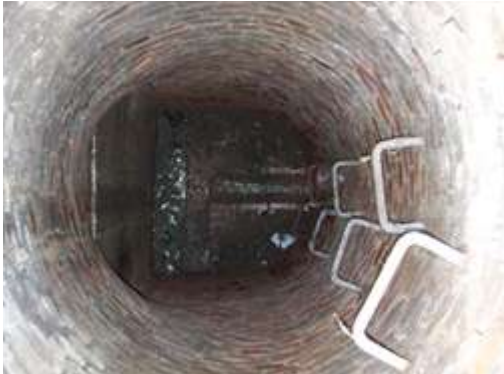
Defect 3

Count: **8** Missing: **1** ☒ **Corroded**

☒ **Evidence Of Surcharge** Depth: **6** (ft.) ☐ Active Surcharge Present

CORRODED STEPS AND EVIDENCE OF SURCHARGE.

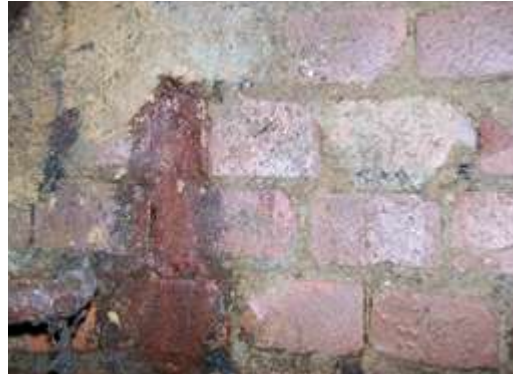
Defect 2

Infiltration: ☐ None ☐ Joint ☐ Cracks ☐ Mortar ☐ Roots ☒ **Wall**

INFILTRATION ON WALL OF BARREL

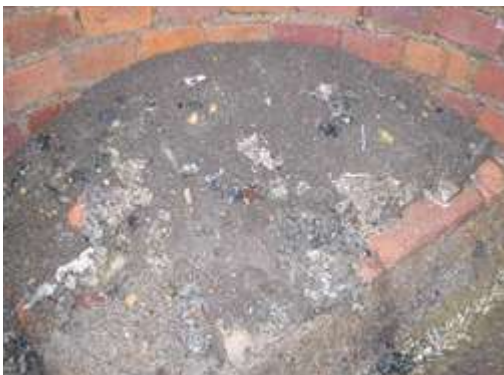
Defect 1

Condition: ☐ Sound ☐ Cracked ☐ Root Intrusion ☐ Deteriorated ☐ Leaks ☒ **Debris**

DEBRIS ON BENCH AND CHANNEL

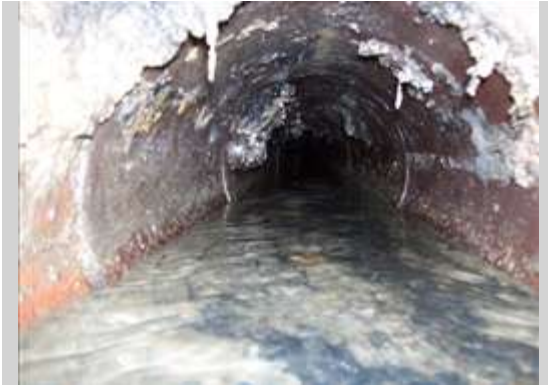
12 O'Clock Outflow

10 in. Circular Gravity Sewer
Pipe Out @ 12 O'Clock

Pipe Height: (in.) Direct
Pipe Material: **Clay** ☐ Pipe Lined
Invert Depth: **14.10** (ft.) Flow Characteristics: **Fast**
Deposits: ☒ None ☐ Mud ☐ Sludge ☐ Debris ☐ Grease
Silt Depth: (in.) Deposits Extent:
Infiltration: **None** Pipe Seal Cond: **Sound**

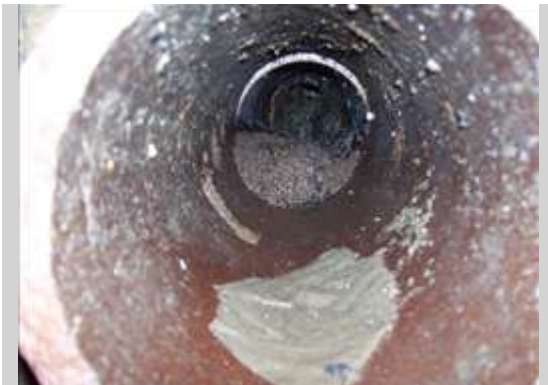
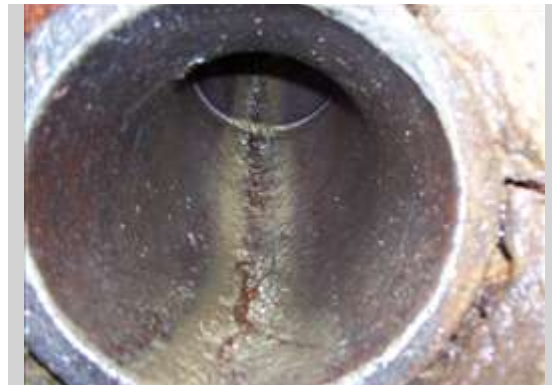
3 O'Clock Inflow

6 in. Circular Gravity Sewer
Pipe In @ 3 O'Clock

Pipe Height: (in.) Direct
Pipe Material: **Clay** ☐ Pipe Lined
Invert Depth: **9.40** (ft.) Flow Characteristics: **Fast**
Deposits: ☒ None ☐ Mud ☐ Sludge ☐ Debris ☐ Grease
Silt Depth: (in.) Deposits Extent:
Infiltration: **None** Pipe Seal Cond: **Sound**

Drop: **Outside Direct**
Angled: Reading: (ft.)
Inv Depth: **13.09** (ft.)

Drop Condition: **Open**

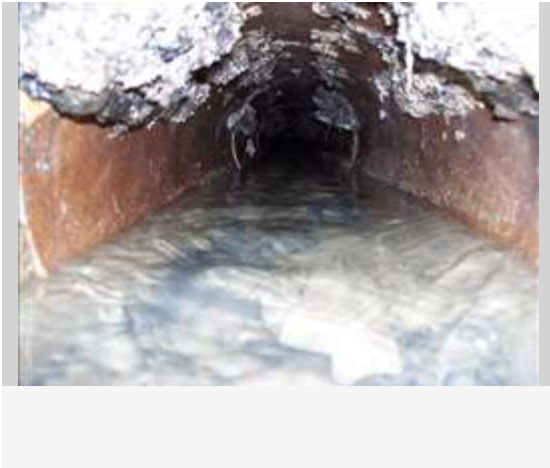
6 O'Clock Inflow

10 in. Circular Gravity Sewer
Pipe In @ 6 O'Clock

Invert Depth: **14.00** (ft.) Flow Characteristics: **Fast**

Infiltration: **None** Pipe Seal Cond: **Sound**
